**Biological Technical Report for the First Line of
Defense (FLOD) 5-Year Maintenance Projects, Near
the Foothills of the San Gabriel and San Bernardino
Mountains, Rancho Cucamonga to Yucaipa
San Bernardino County, California**

Submitted to:
**San Bernardino County
Flood Control District**
825 East Third Street
San Bernardino, CA 92415

June 2015

Submitted by:
ECORP Consulting, Inc.
ENVIRONMENTAL CONSULTANTS

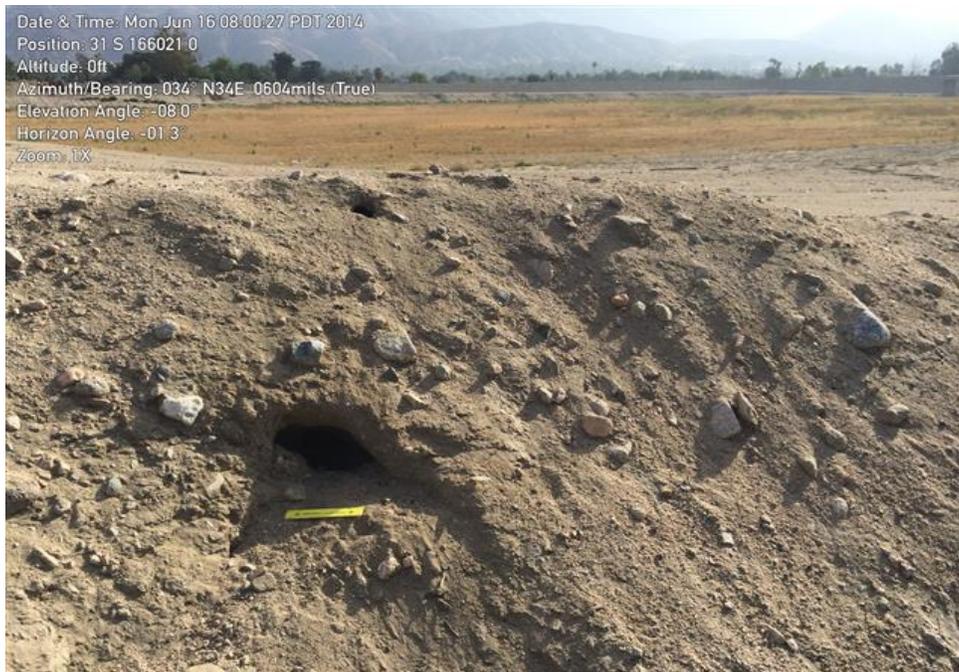
Photo 2. Looking north from western portion of BSA. Potential burrowing owl burrow in the berm surrounding the basin. Photo taken: 6/16/2014.
